STATE OF NEW YORK
DEPARTMENT OF TRANSPORTATION

1998 CANAL
IMPOUNDING EMBANKMENT
CONDITION SURVEY

GEOTECHNICAL ENGINEERING
BUREAU

SEPTEMBER 1999

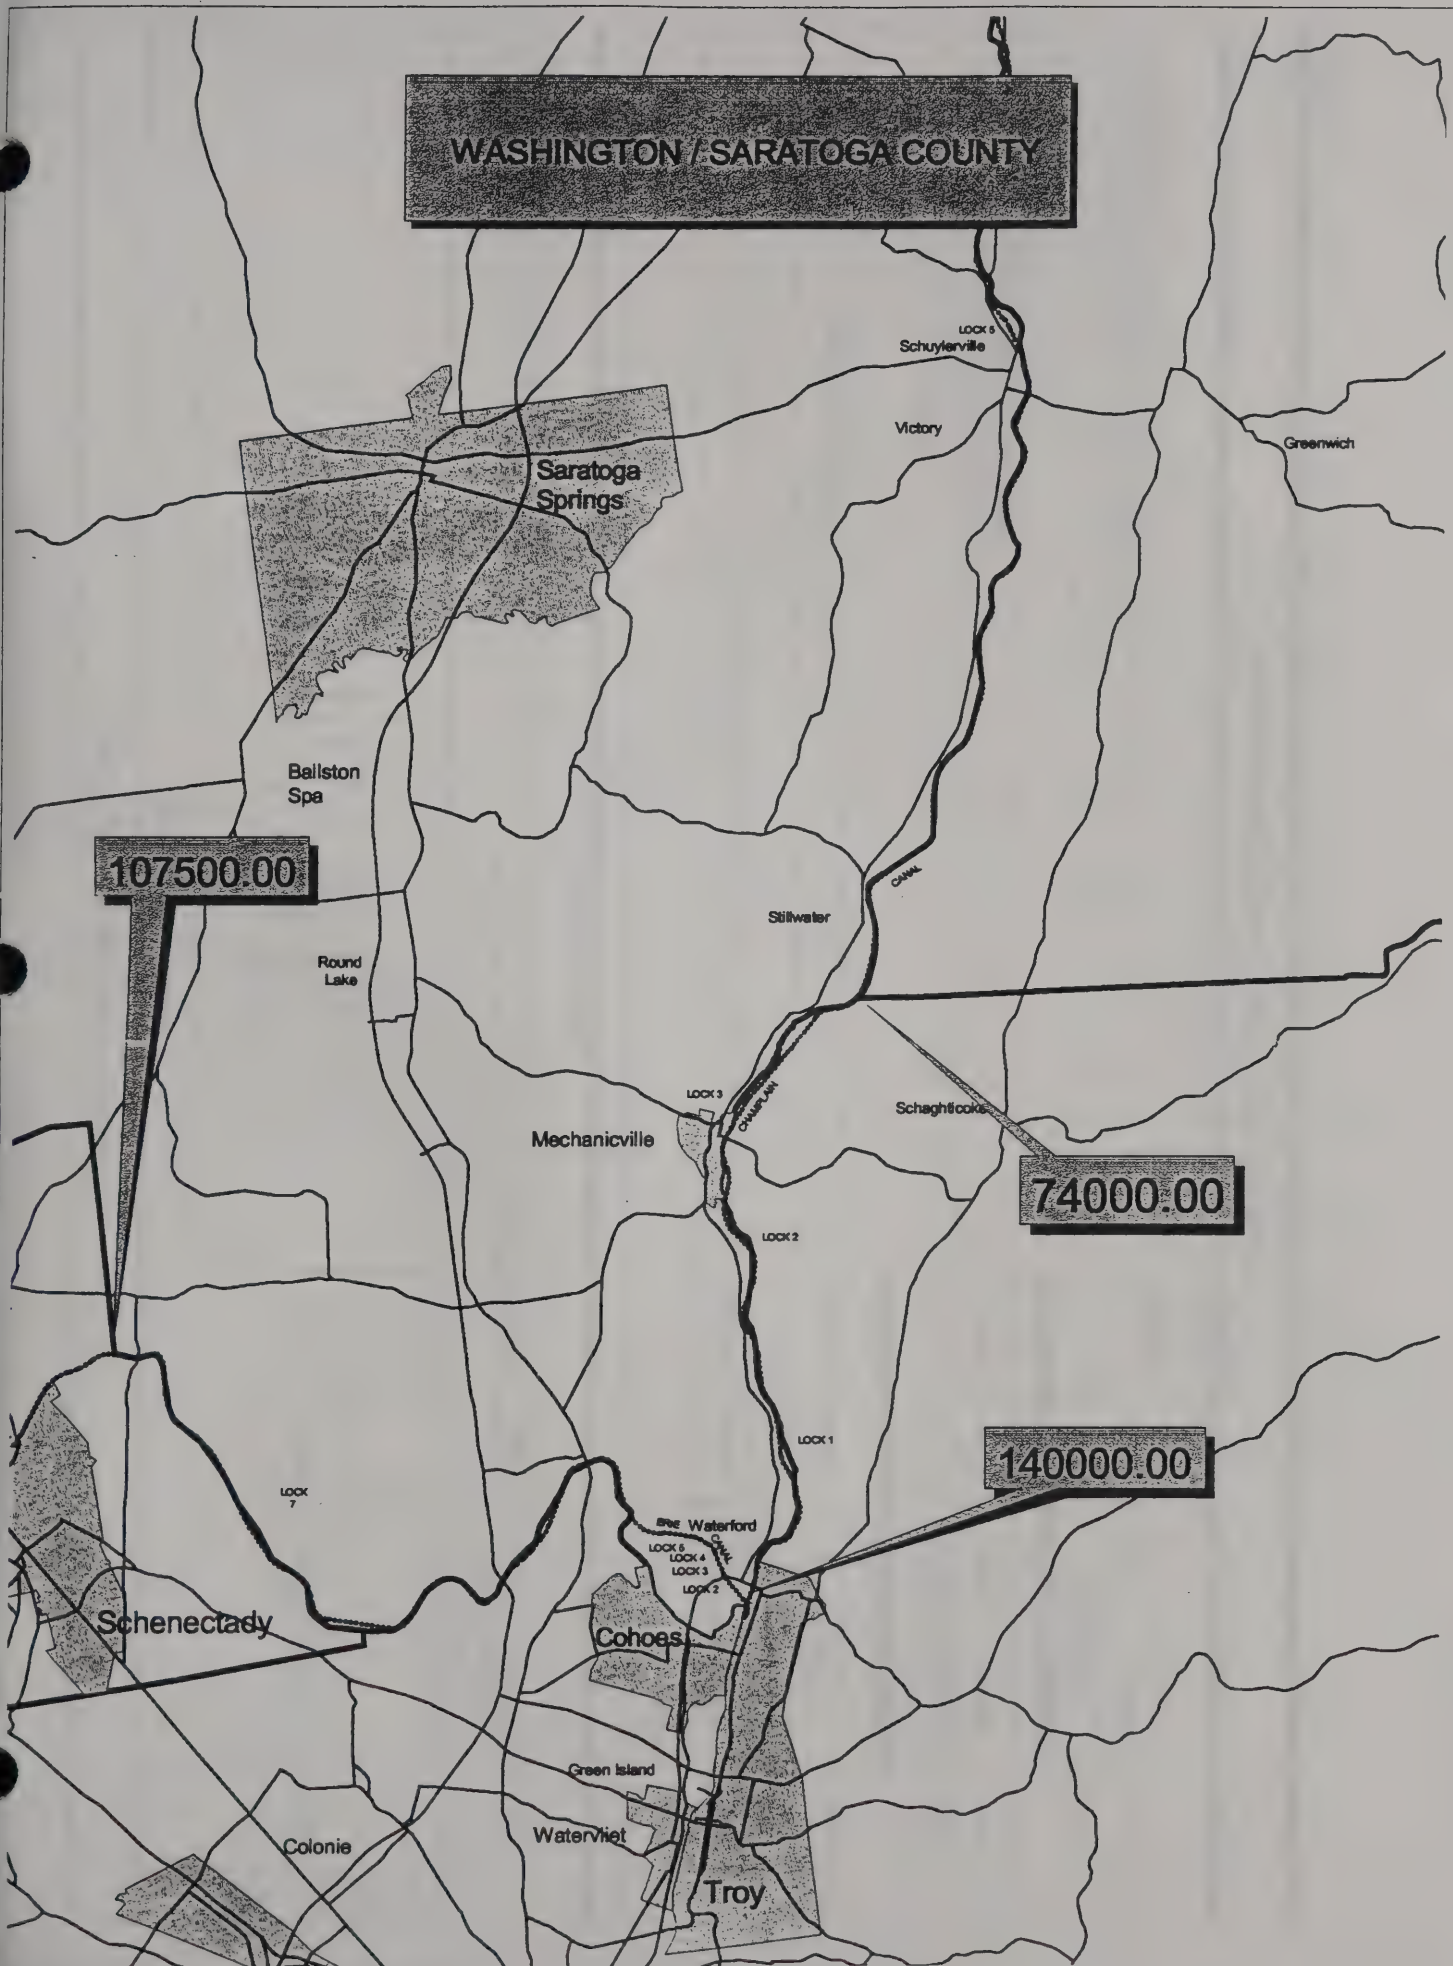
WASHINGTON / SARATOGA COUNTY

SUMMARY FOR 1998 INSPECTION

DOT REGION	DIVISION-SECTION	CANAL STATIONING		OFFSET	COUNTY	RISK ASSESSMENT										COMMENTS
		FROM	TO			SEEPA AGE	WIDTH TOP	EMBANKMENT OUTBOARD	HEIGHT OUTBOARD	SLOPE OUTBOARD	GROWTH OUTBOARD	INBOARD SLOPE	ADJACENT TERRAIN	TOTAL	RATING	
1	ALB-1	CHAMPLAIN CANAL		EAST & WEST SIDE	WASHINGTON	0	9	3	12	2	0	0	0	26	5	Site directly North of Lock C-6. Old canal at toe.
		165+50	170+00													
WASHINGTON COUNTY																
		CHAMPLAIN CANAL														
1	ALB-1	897+50 (Lock C-3)		WESTSIDE	SARATOGA	0	0	2	6	0	0	0	0	8	7	
		OLD CHAMPLAIN CANAL														
1	ALB-1	in WATERFORD		EASTSIDE	SARATOGA	0	0	0	0	4	1	5	10	7	Fulton ST. to G.E. Landfill	
1	ALB-1	GLEN FALLS FEEDER														
1	ALB-1	96+00	168+00	SOUTHSIDE	SARATOGA	15	0	5	6	2	0	1	29	2	Rt 4 to Quaker Rd- Wet along toe of slope - Comment and drawing with inspection form	
1	ALB-2	ERIE CANAL														
1	ALB-2	234+00	242+00	NORTHSIDE	SARATOGA	5	0	4	6	2	0	5	22	6	Lock E-4, Boil visible within lock - Wet along toe of slope. Comments and drawing with inspection form

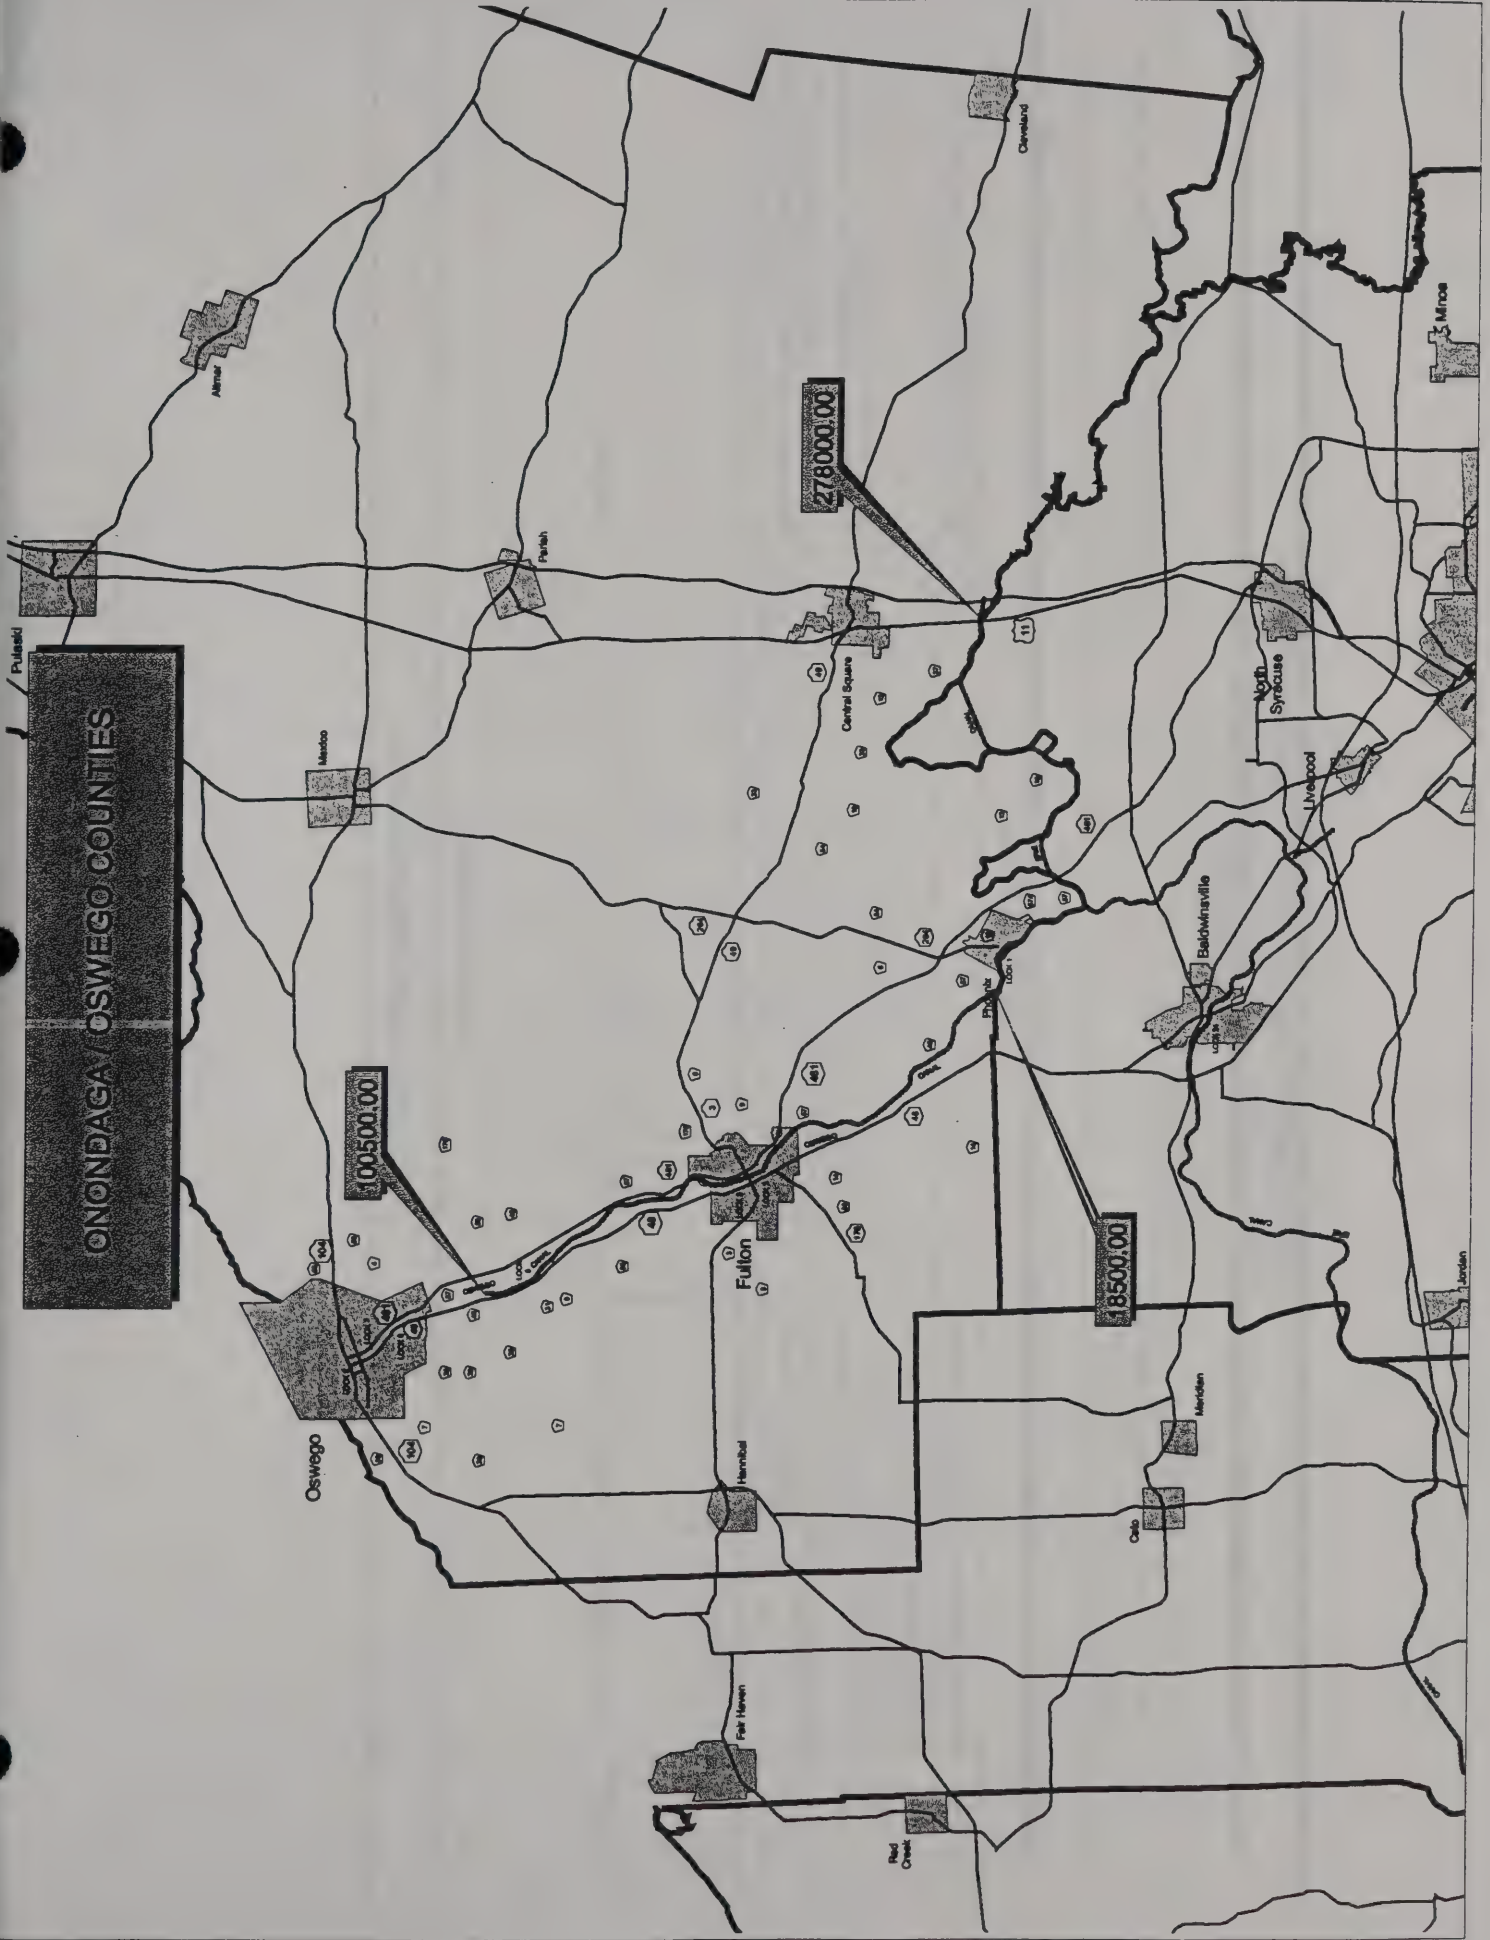
ONONDAGA / OSWEGO COUNTIES

SUMMARY FOR 1998 INSPECTION

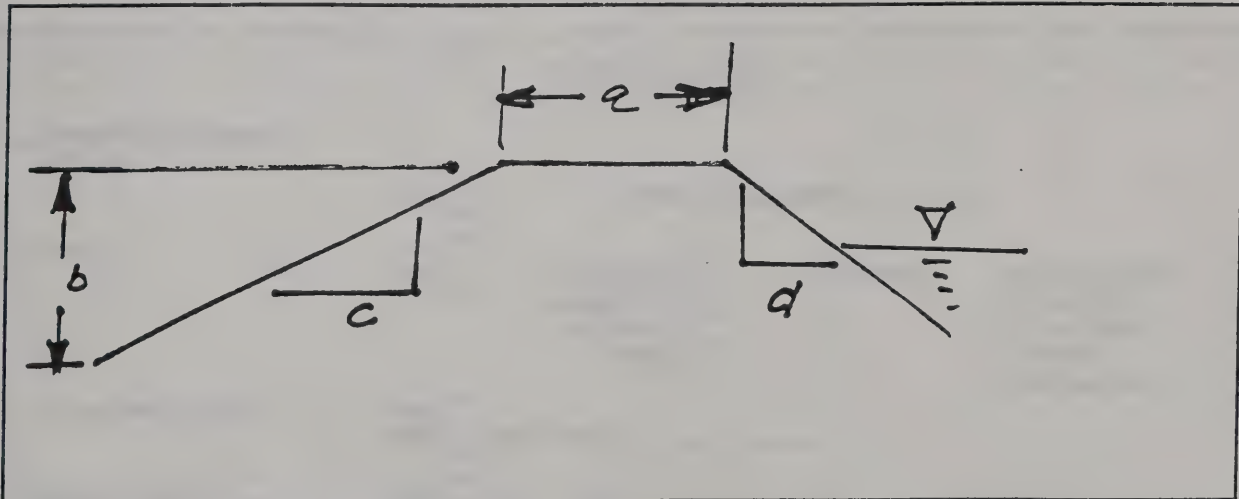
EMBANKMENT GEOMETRY

- a. ESTIMATED TOP WIDTH _____
 b. ESTIMATED OUTBOARD EMBANKMENT HEIGHT _____
 c. OUTBOARD SLOPE = 1 VERTICAL ON _____ HORIZONTAL
 d. INBOARD SLOPE = 1 VERTICAL ON _____ HORIZONTAL
